Turn Signal Switch adjustment

1963 thru 1968 Sunbeams using LUCAS repair kit # 54325591

- Tiger Tom (7-26-18)

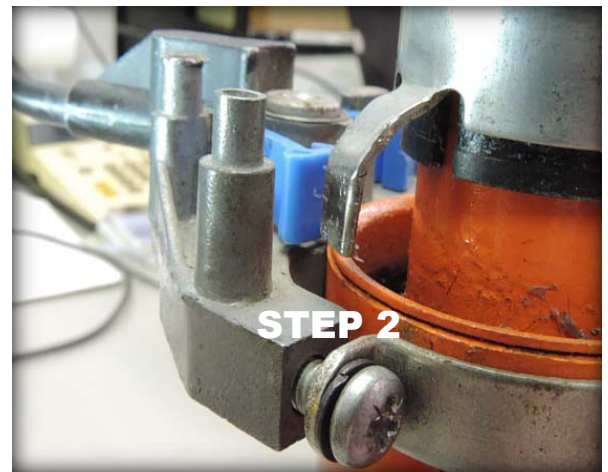
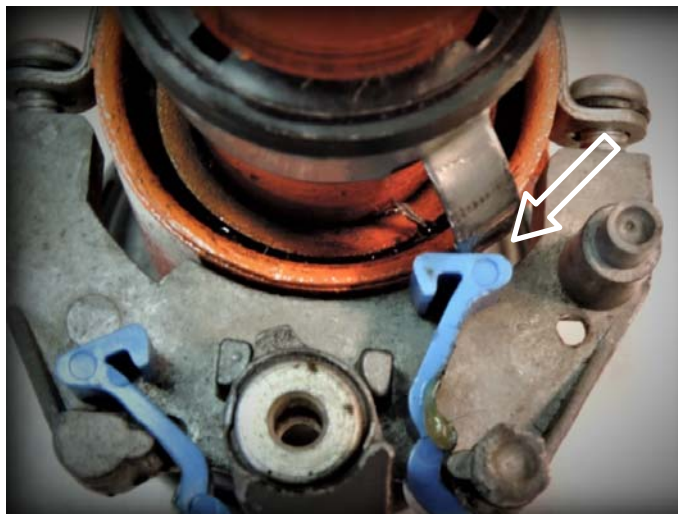
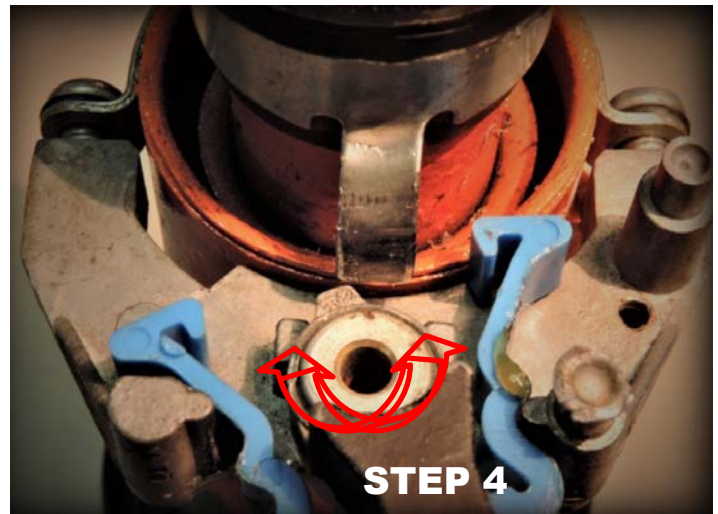
British cars using this repair kit design have a high turn signal mechanism failure rate, in part, because of a design factors. The failures are exacerbated by miss adjustment, especially when replacement plastic arms are installed.

Step 1. Bend STRIKER BLADE so that it does NOT cancel.

Step 2. Bend STRIKER BLADE so it just barely cancels when turned slowly.

Step 3. Adjust cancel in opposite direction. See step 2.

Step 4. Twist STRIKER BLADE so Step 2 is equal in both directions.
