Horn Ring Reinforcement and Repair

By John Logan

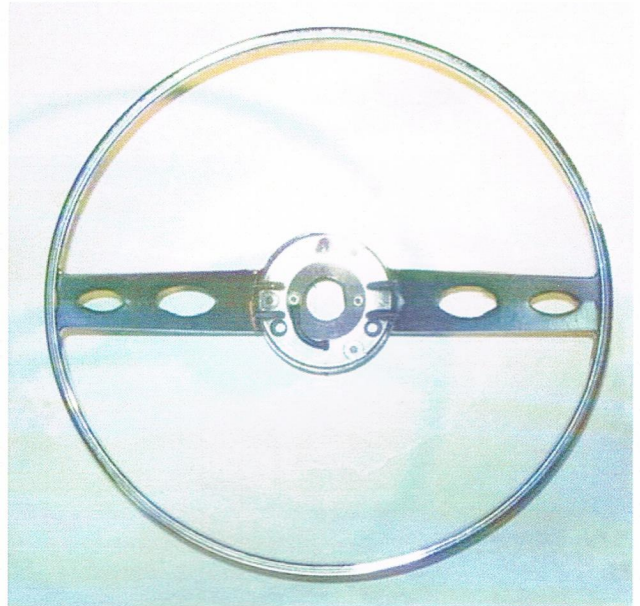
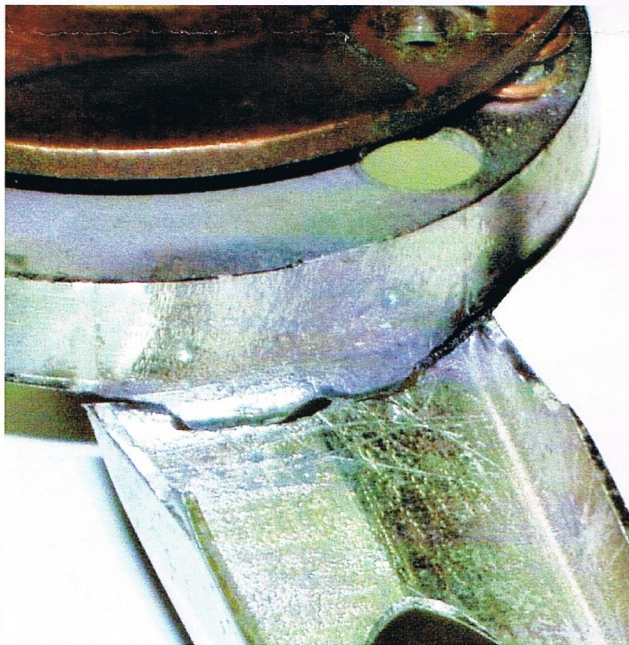
A Cracked Spoke

The hub end of the horn ring is a very poor design. The spokes have very thin notched sections at their highest bending moment, so it's a wonder that some have lasted as long as they have. The reproductions that I've seen are much stronger in that area. Fix or reinforce both spokes at the hub even though only one side is broken. If the spoke is broken on the ring side or if the ring is broken, it's probably not worth fixing.

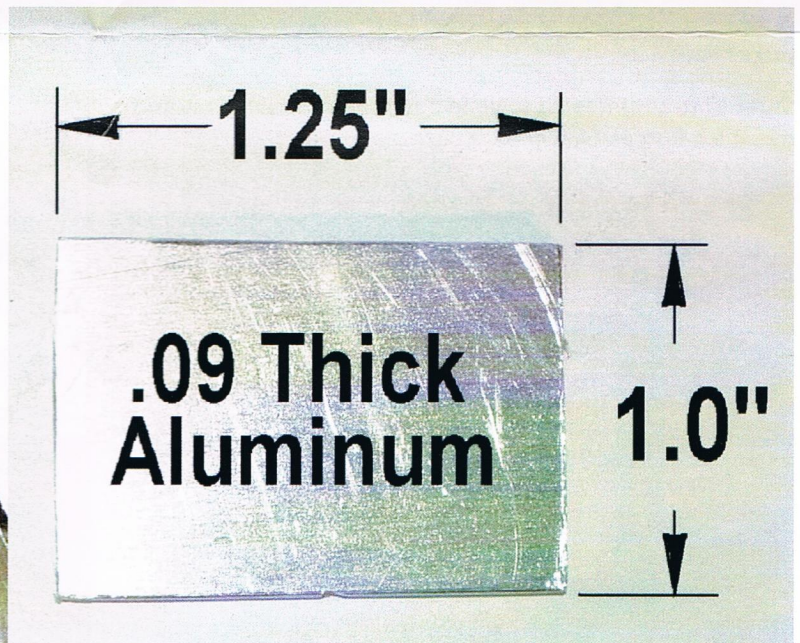
Reinforcement Blanks

I made the reinforcements out of .09" X 1.0" aluminum stock because it's easy to bend. You could also use steel. By cutting them longer than needed it is easier to hold them while bending.
