Adding a Ground Connection to a Series V Fuel Sender

Michael Hartman
Version 1.3
February 14, 2017

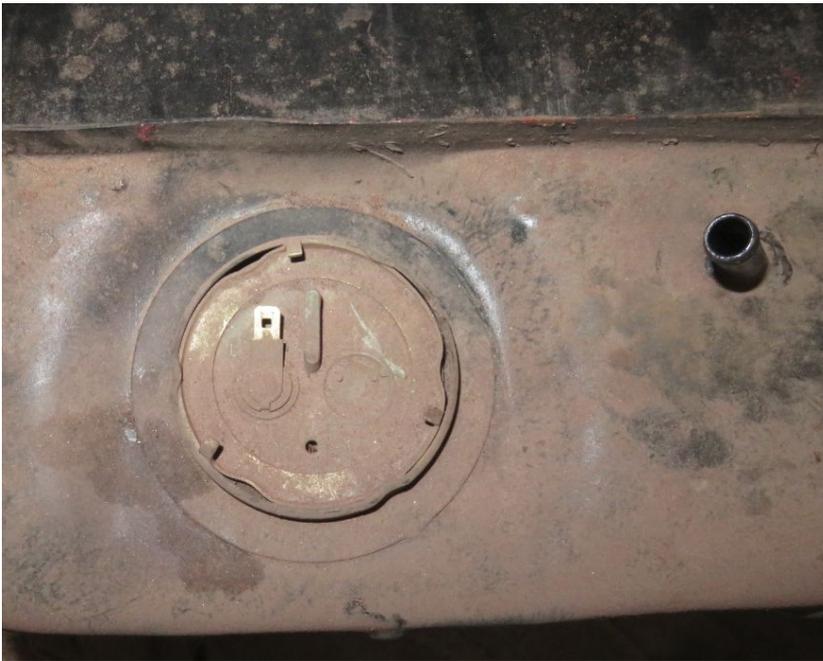
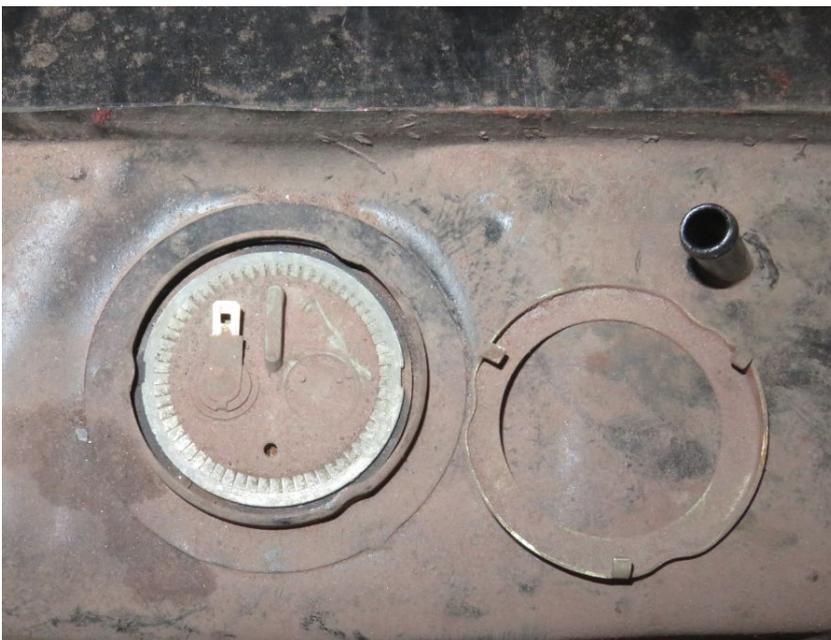
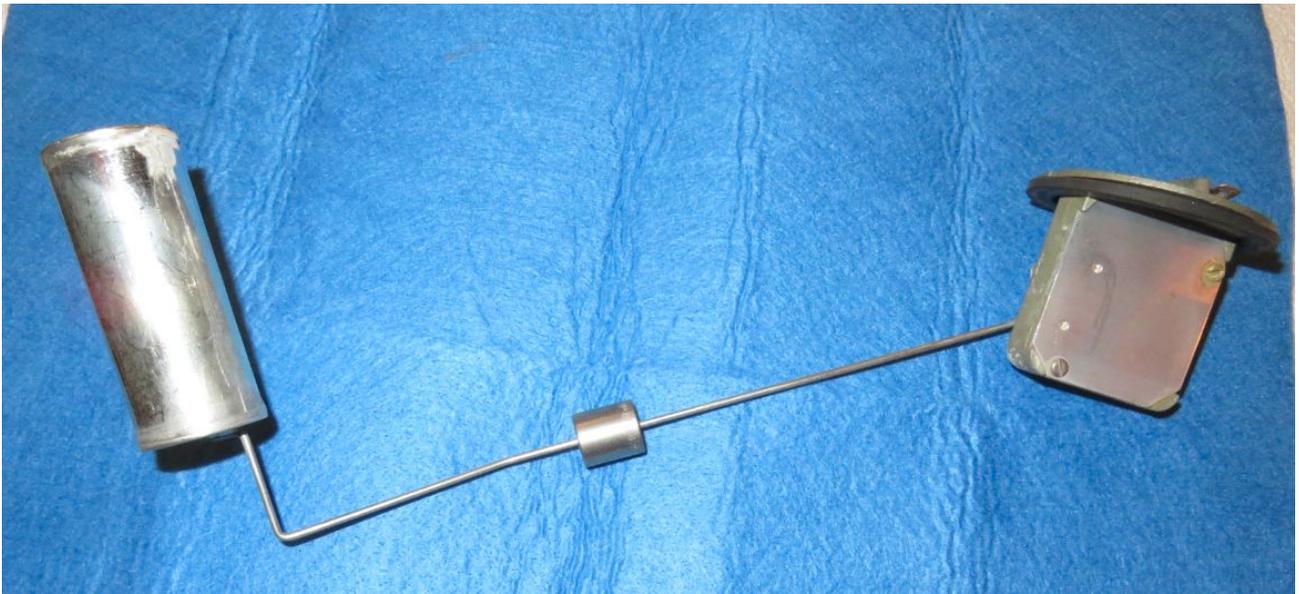
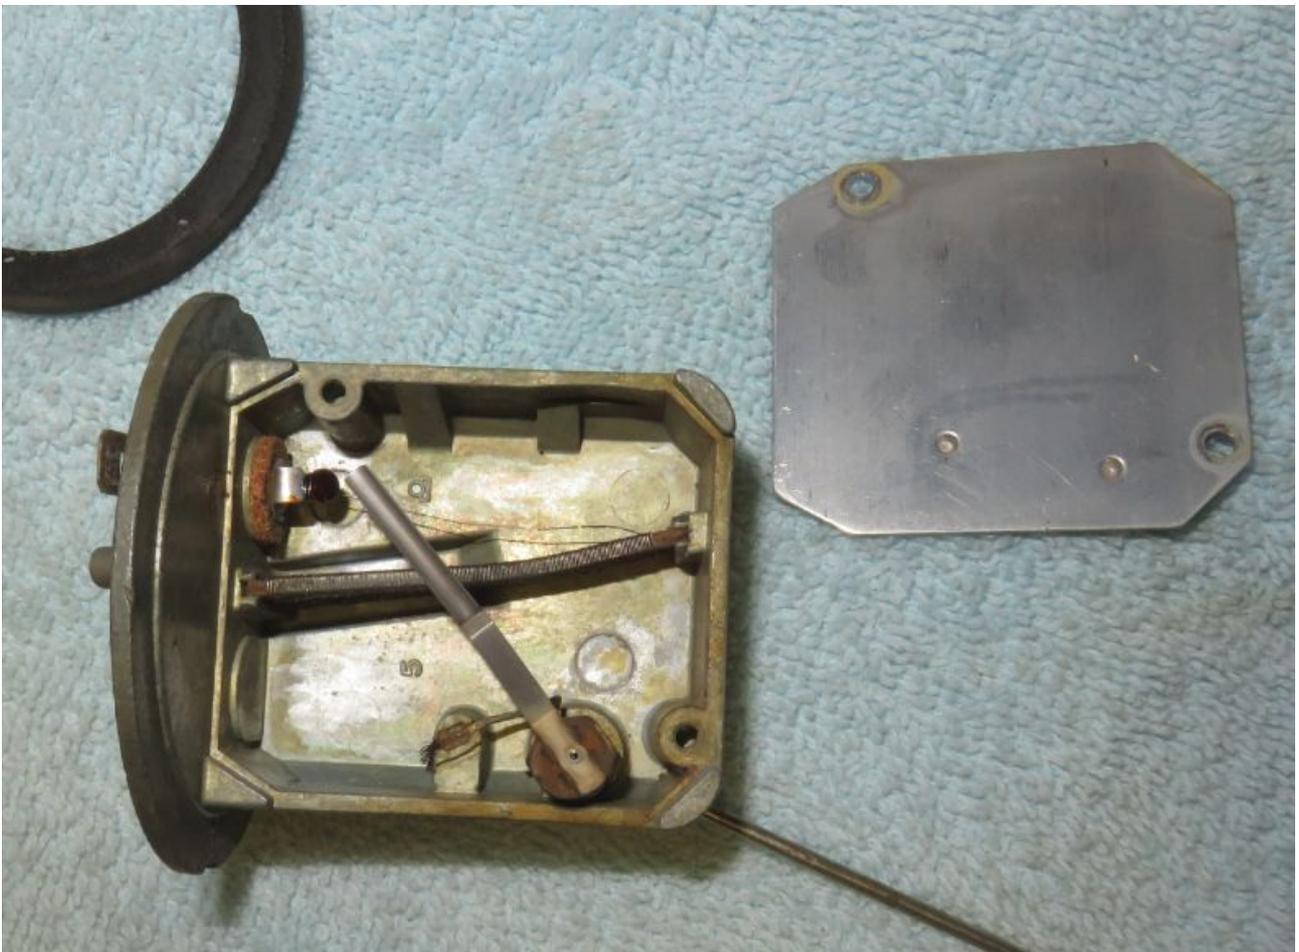
My gas tanks passed the tipping point and my fuel filter was capturing too much crud. So I pulled the tanks (for cleaning and sealing) and the fuel sender. The sender was giving erratic resistance measurements.

The sender has a braided cable to connect the wiper arm to the housing body. From what I could tell with my multimeter, the braided cable was not making a good connection anymore. The braided cable was just pushed into the slot via some high force press. No weld or solder used.

The grounding scheme for the sender housing is not ideal. The braided cable needs contact with the housing. The top of the housing needs good contact with the bottom of the metal retaining ring. The retaining ring then needs good contact with the "pinches" in the gas tank opening. Then the gas tank needs good contact with the car frame (no worries there). Accumulation of dust & dirt over the

years, vibrations, rubber gasket shrinkage, etc. and the connection is likely to become broken.

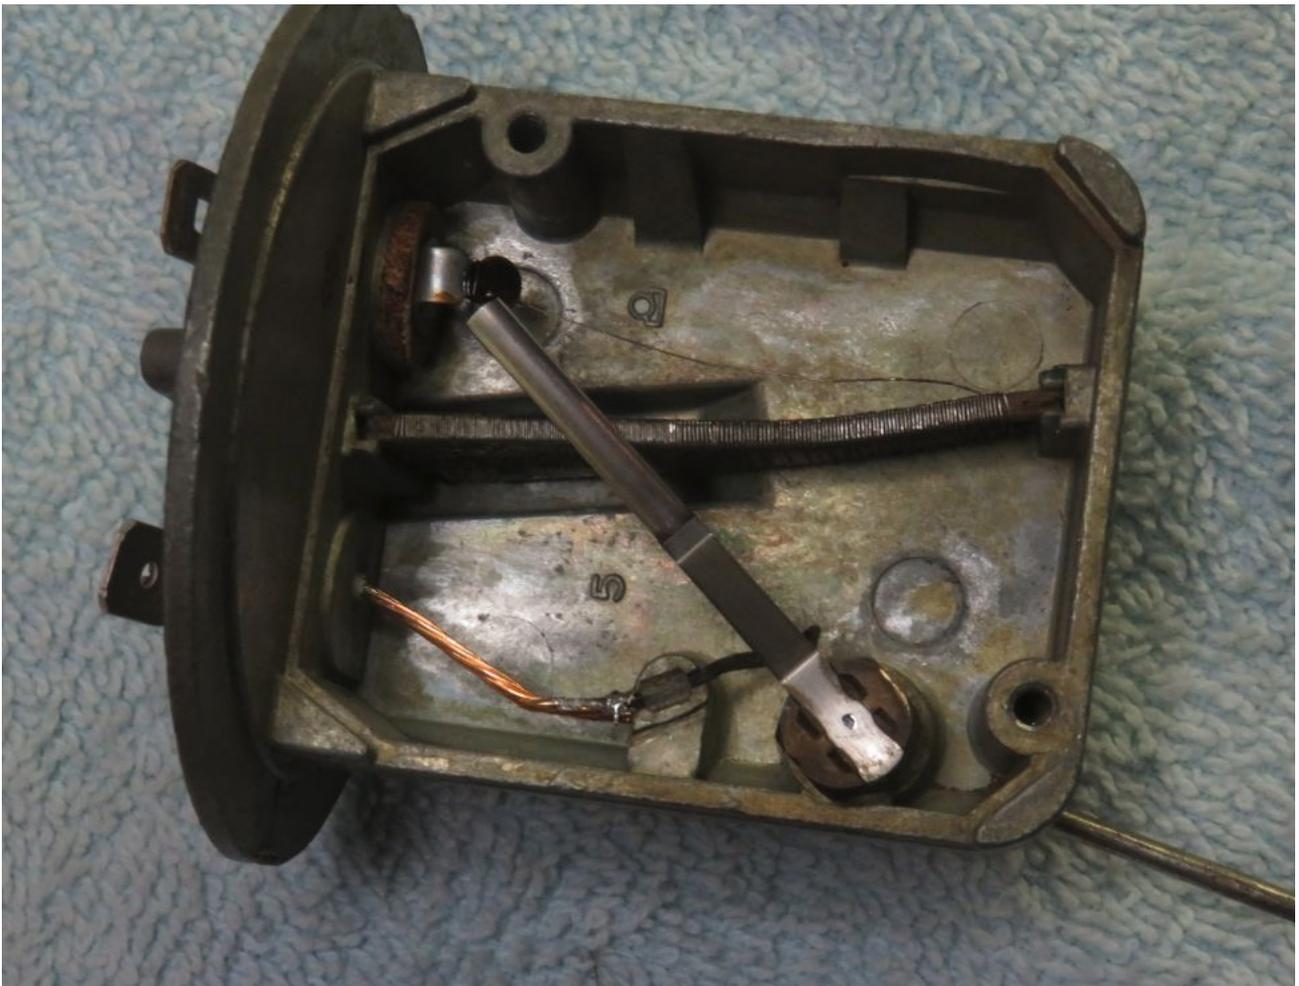
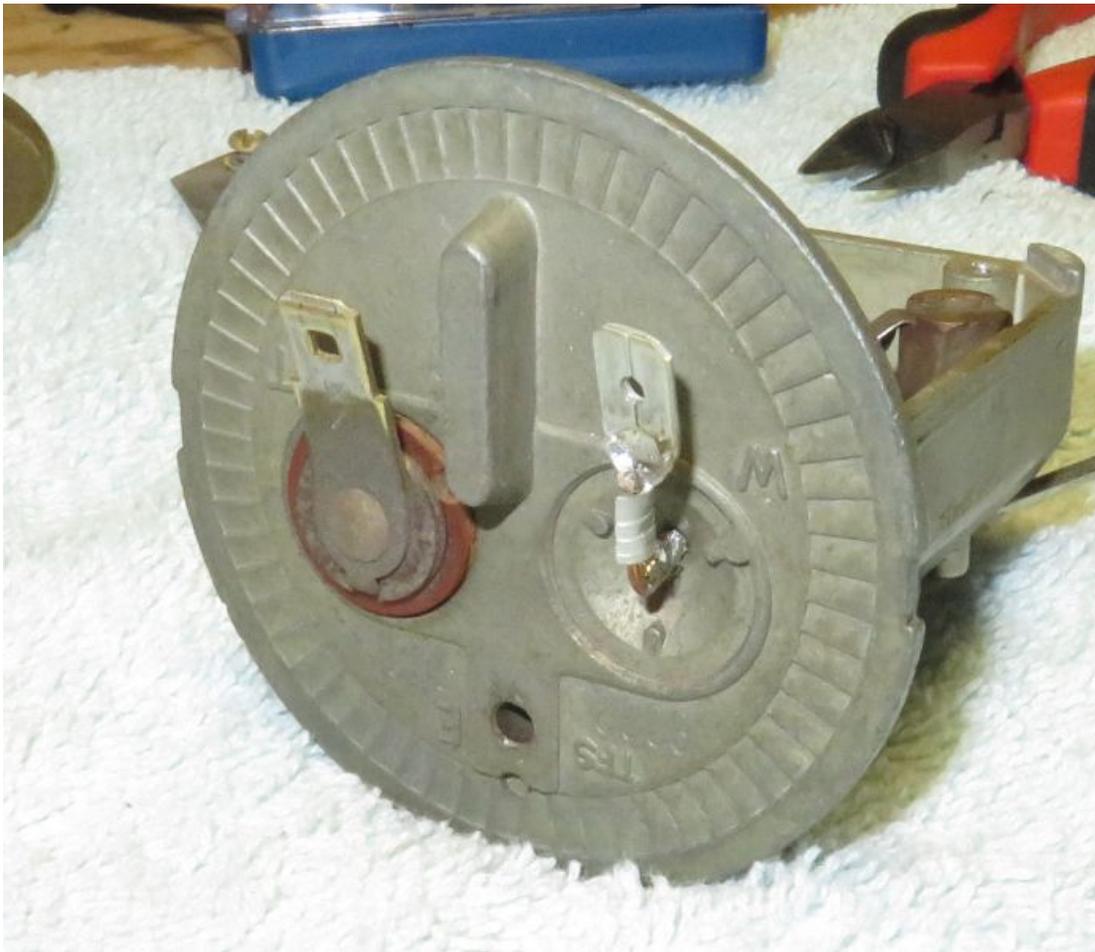
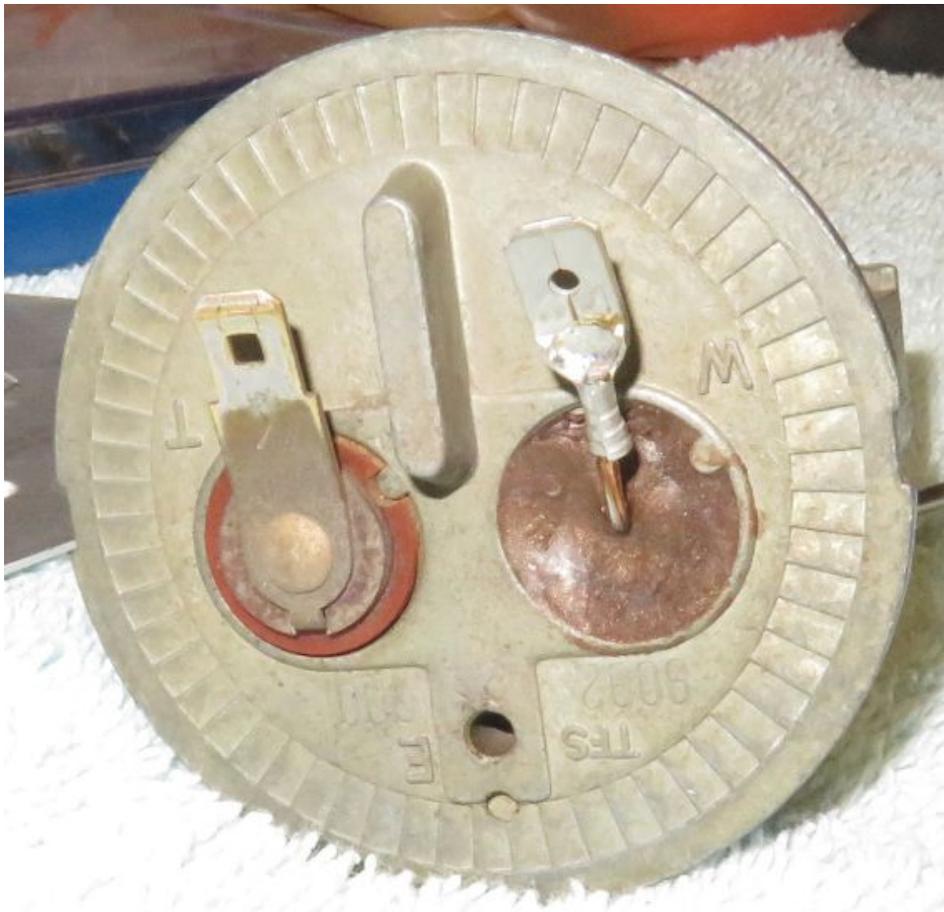
There is a second blank plate area in the sender top, as if there was a thought to have a second connection come through the sender top. There was probably a design revision where a dedicated grounding connection came through that second blank plate. Likely a bean counter deletion at some point.

I ended up drilling a hole in the cover blank, ran an 18 gauge stranded wire through the hole I had drilled, then soldered the 18 gauge stranded wire onto the braided cable end. Then I soldered a 1/4" male quick disconnect onto the stranded wire. I sealed up the hole I had drilled in the cover using Permatex fuel tank repair epoxy. The epoxy serves two purposes - sealing the hole and also locking the stranded wire in place to prevent any strain on the braided cable.

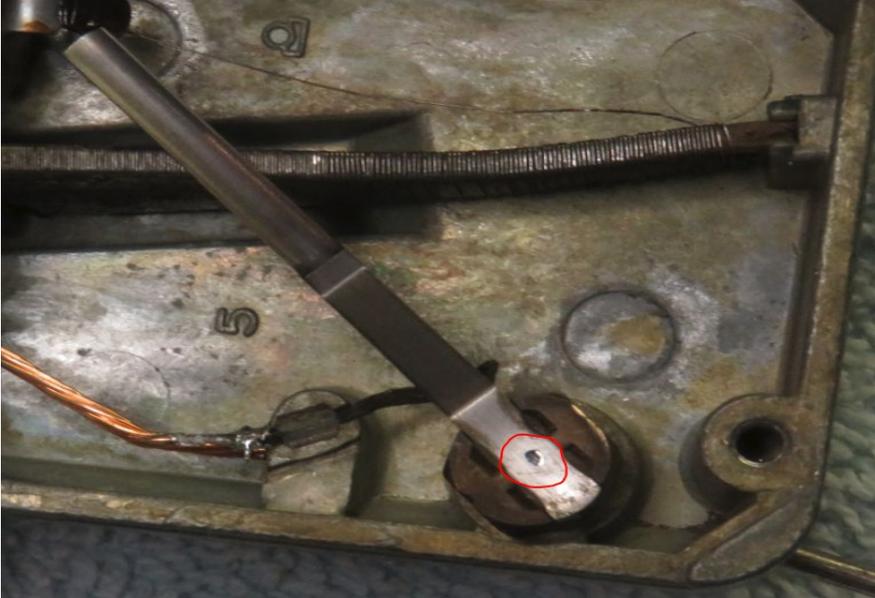
After reassembly, I tested the sender using a multi-meter. The "full" position was reading around 18 ohms. The "empty" position was reading around 250 ohms. However, I noticed some erratic readings near the fully "empty" position. All other readings were coming in solid. I removed the cover plate again. There definitely was some wear between the cover plate dimple and the sweep arm mount. There is some slop in the sweep arm mount. The wear could be reducing the contact force of the sweep arm on the wiring windings.

I used a 5/32" punch and a hammer to push the dimple farther into the inside of the cover plate. I moved the dimple .003". (Note: I positioned both dimples over small holes in a piece of wood when using the punch to avoid bending the cover plate and avoid flattening the dimple being punched.)

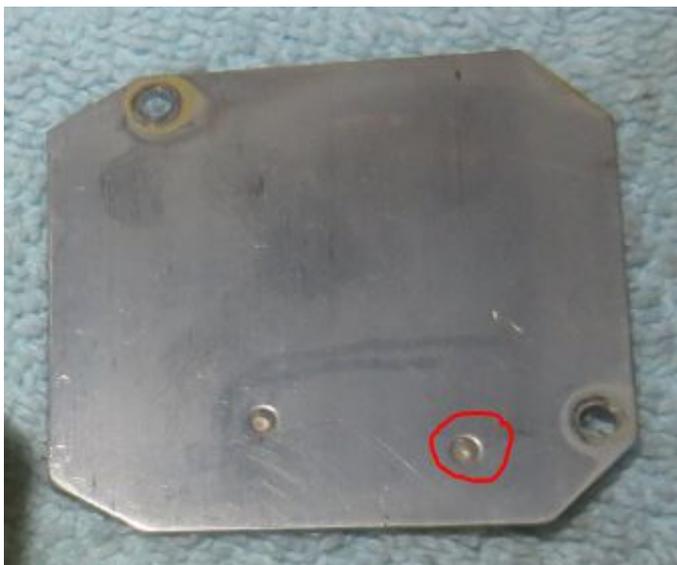
Here is a photo showing the dimple that was pushed in .003".

I reinstalled the cover plate and re-tested the sender. There were no more erratic readings at the fully "empty" end.
