Relief Valve Change Can Cure Alpine LOP

by Tom Ehrhart

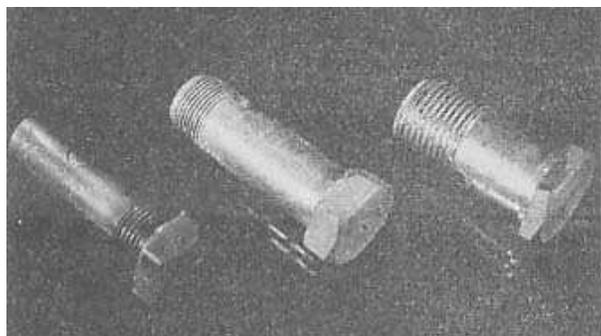
Fig 1

The oil pressure relief valve is a component in our engines that has a significant effect on oil pressure as a potential failure mode. But, it too, can be modified to increase oil pressure. It's an easy task and can be undertaken by anyone with a few basic tools. There are three types of relief valves in Alpine engines, depending upon engine serial and series number. (see Figure 1) They appear physically different, but all operate in the same manner, i.e. excess oil supplied by the oil pump causes the spring-loaded plunger to open up past the holes on the side of the valve, in turn allowing excess oil to drain back down into the oil sump. If a relief valve is "stuck", causing LOP, it will be obvious by noting that the plunger does not move freely nor does it completely close the side ports.

Start the modification by removing the relief valve with a 1 3/16th" wrench. Again, refer to Figure 1 to determine the type of valve you have. For this article, the one on the left was used (1725cc). The other two are used in the 1592cc and 1494cc engines.

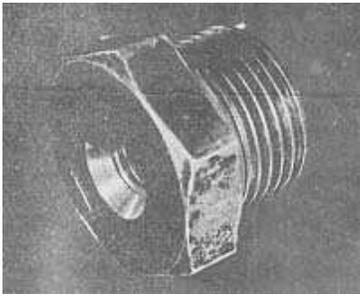
Fig 2

The 1725cc valve is disassembled by using a propane torch to unsolder the copper tube from the threaded housing. The other valves are disassembled by carefully filing or grinding the ends off. They are re-assembled by peening over the ends that were filed away. The remaining modifications are the same for all three valves. The next process involves drilling a hole through the end and center of the valve and tapping it with 10?32 threads. After the tapping is done, countersink the hole slightly. (see Figure 2 for complete operation)

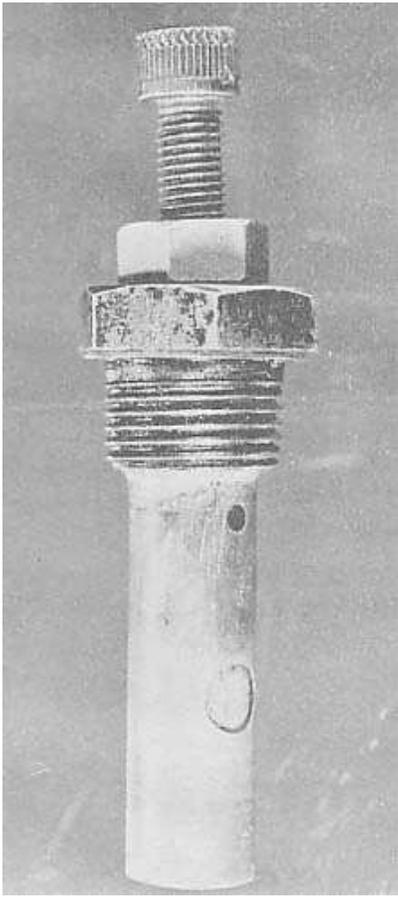
Fig 4

Organize the components as shown in Figure 3. Note the addition of a small disc between the spring and the threaded housing, a rubber "O" ring and a bolt with a nut. Re-assembly begins by placing newly acquired disc into body of threaded housing. Stretch and re-assemble in the reverse order of how the valve was taken apart. Place the small "O" ring on the bolt and screw the bolt into the valve, but do not cause the disc to move. Lightly secure the nut. (see Figure 4)

Install the valve into the engine. Then start the engine and get up to normal operating temperature. A 15-minute trip at highway speeds should do nicely. You should already have noticed a small increase in pressure. Now, with the engine running at 2500 to 3000 rpm, loosen the nut and turn bolt in until desired oil pressure is obtained ? about 50 pounds or more for street use. Remove valve from engine, clean in a solvent and smear silicone form a gasket around the threads and "O" ring before tightening the nut for the last time.
