## The Reincarnation of a Cracked

### Steering Wheel Hub

By John Logan

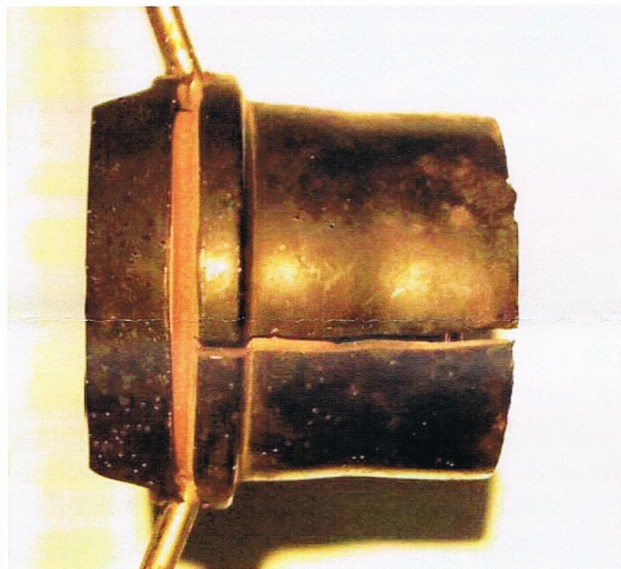
If your Sunbeam's steering wheel hub looks like the photo above, it's a victim of a natural aging process. The Bakelite and hard rubber of the '50s and '60s just wasn't as stable as today's plastics. They continually outgas like ice cubes left too long in the freezer.

The plastic on the steering wheel has to crack because it's restrained by the steel structural cup inside.

be replacing the cracked plastic with new components (see below): a sleeve made from a 3" aluminum tube pressed on the wheel's structural cup and held by Plexiglas sections above and below that are glued together. Three drilled and tapped screws with nuts replace the cast-in threaded inserts of the original hub.
